# EVALUATION OF IN-SITU ELECTROSPUN NANOFIBER SCAFFOLDS IN HARD-TO-HEAL WOUNDS

**Dr. Charalambos Agathangelou** MD, PhD Medical Gerontology, PhD Dermatology and Venerology.  
Director at Dhali Community Geriatric, Rehabilitation and Wound Centre, Dhali, Nicosia, CYPRUS

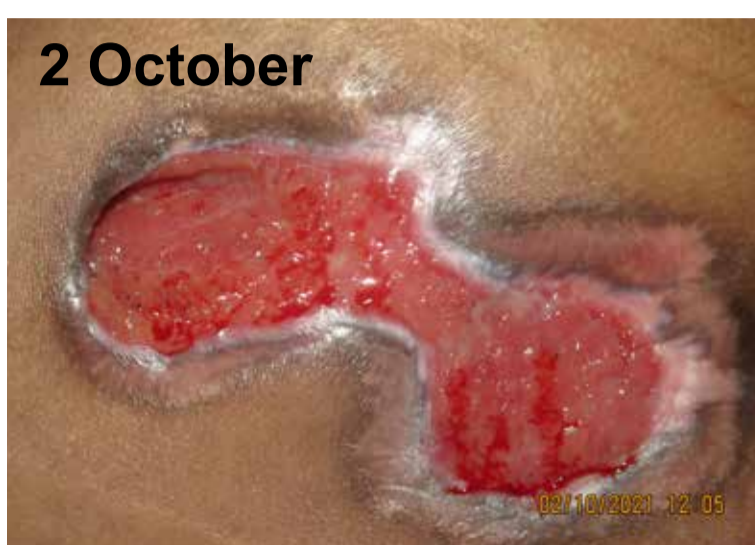
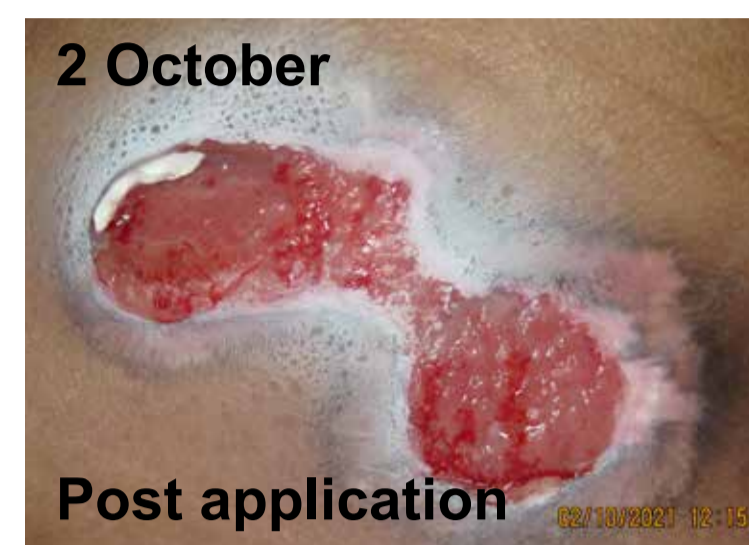
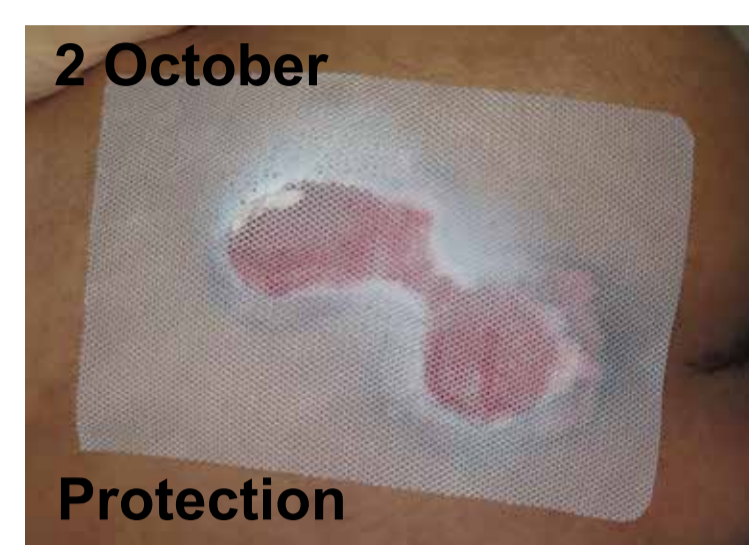
Scaffold applications

30-year-old male, malnourished (in spite of prescribed protein drinks), with a tracheostomy, who has been in the ICU for six months following a traffic accident. During this time, he developed multiple pressure injuries on his sacrum, trochanters, malleolus and heels. Duration of most wounds was 18 months.

2 October  
19 October  
27 November

The pain level dropped to 3 (VAS) after application of the electrospun nanofibrous matrix, so analgesia was no longer needed. After application, the electrospun nanofibrous matrix was covered with a protective non-stick layer as well as a superabsorbent pad, (the pad was to absorb eventual leakage of faeces). We only needed to change the superabsorbent pad on a weekly basis. After 3 weeks the pain level dropped to 0. The 18-month-old wound healed in 3 months.

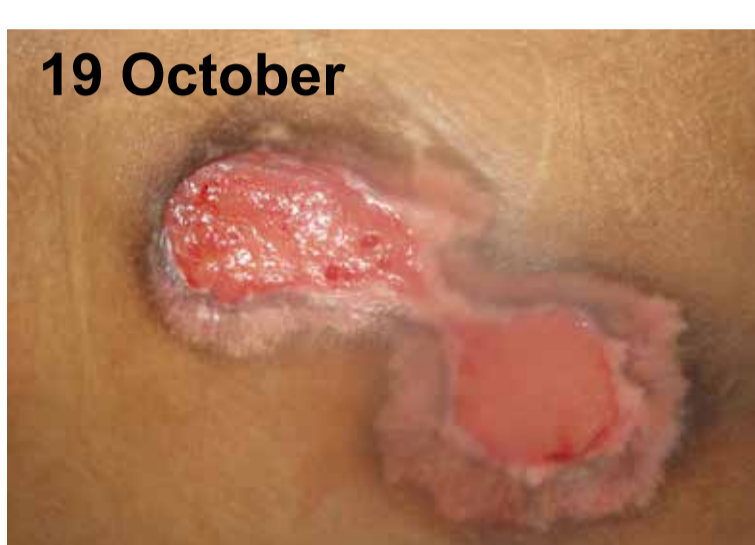
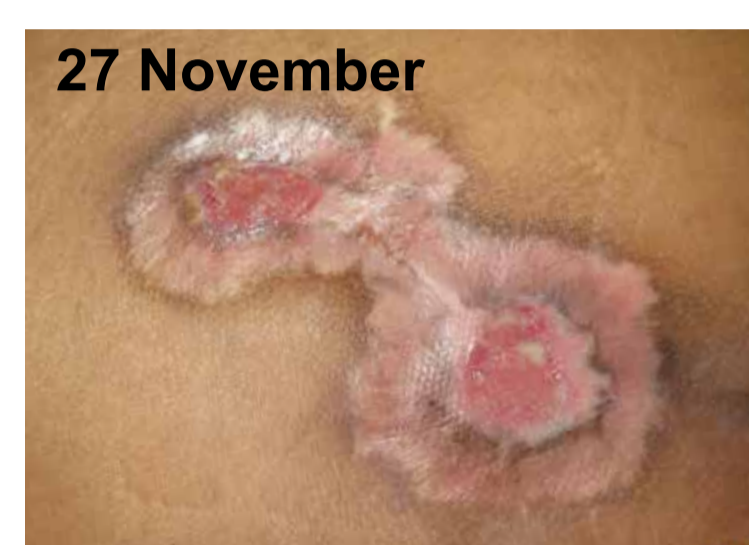
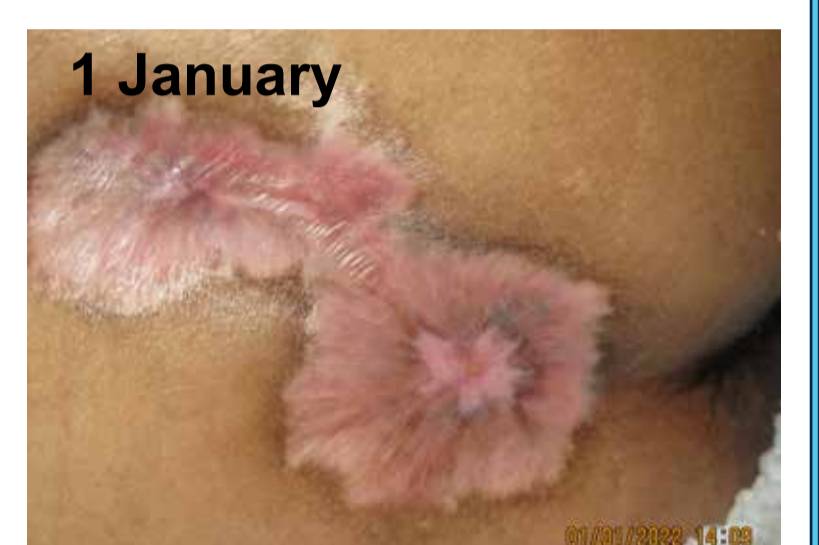
Photos on the left show the wound at time of the 2nd and 3rd scaffold application. Photo to the right shows the healed wound.

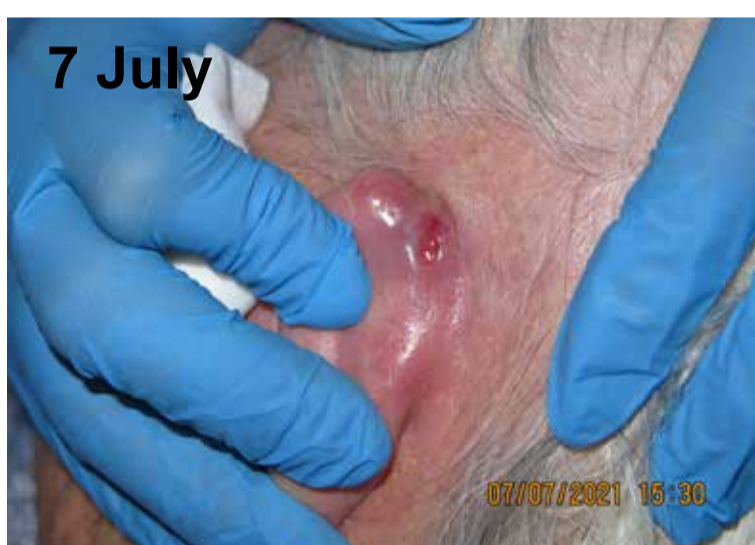
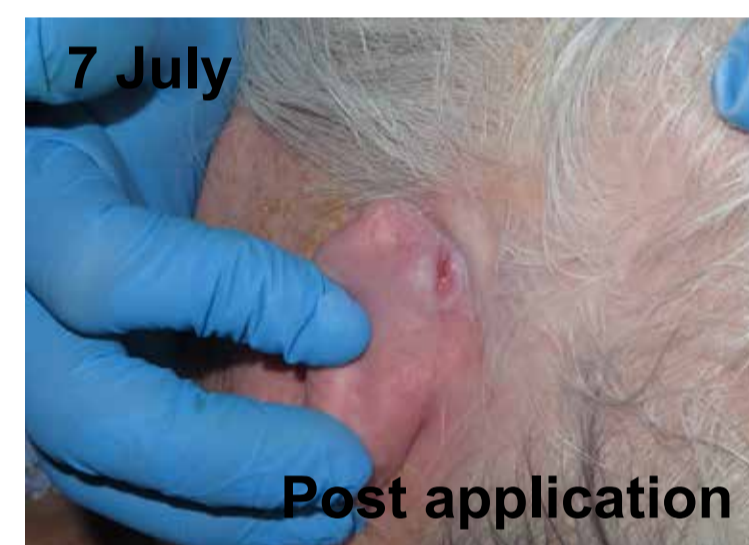
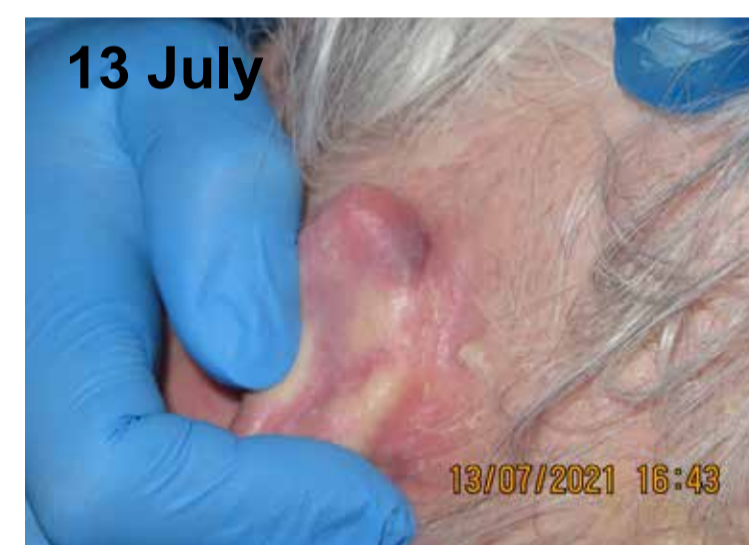
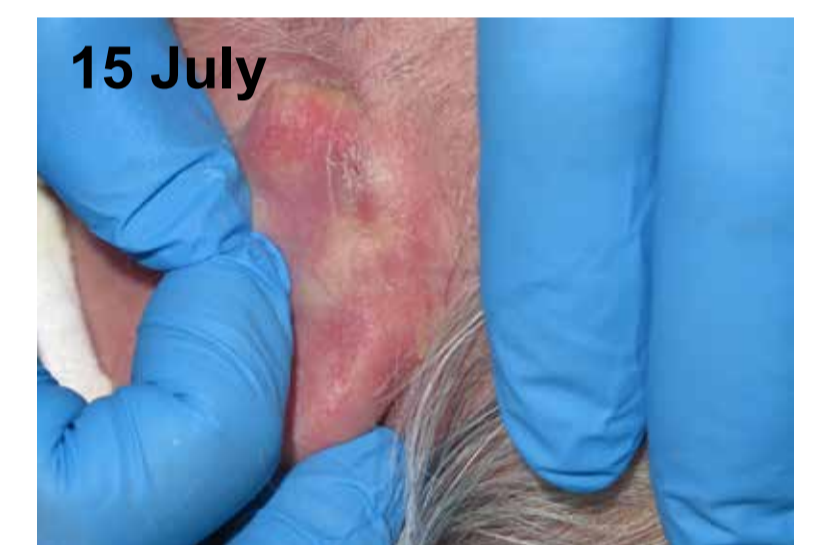
99-year-old female on constant Oxygen flow of 2 liters/minute due to COPD. History of CVAs. Has an NG tube in the last 2 years. Other than that, the patient is alert and verbal. Recurring pressure injuries on the ears due to pressure from the tube. This current pressure injury has been open for six weeks. Previous treatments included hydrogels and hydrocolloids.

Only one application of electrospun nanofibrous matrix was needed, the wound was closed 8 days later. Follow-up six months after healing the wound was still closed showing that the new epithelialization retained its elasticity. Nothing has changed in her condition or care provided.

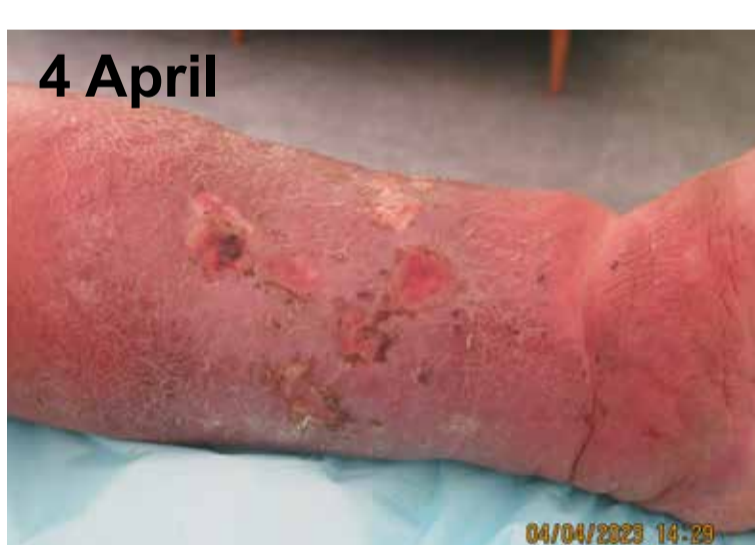
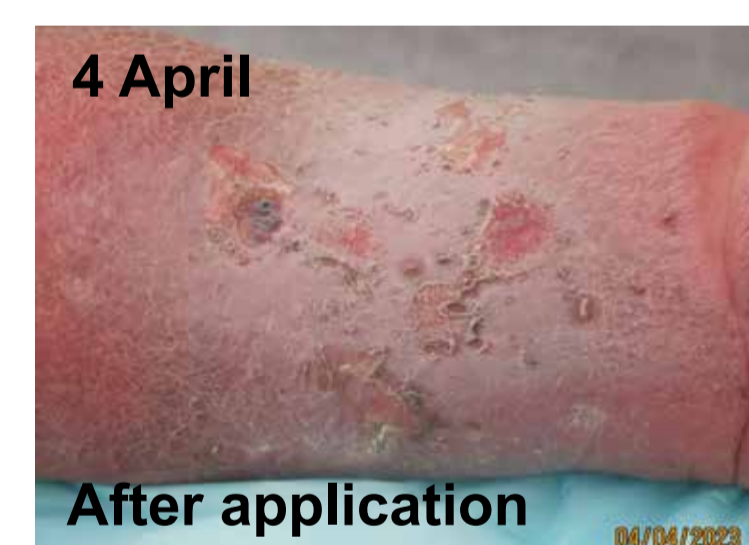
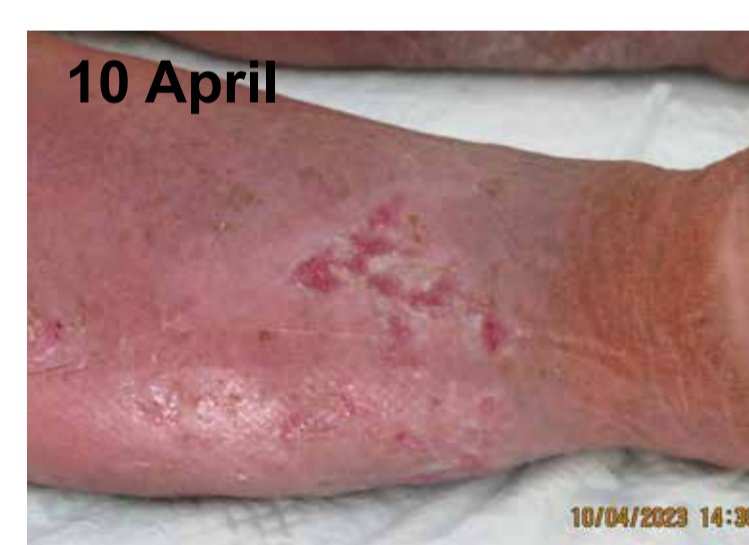
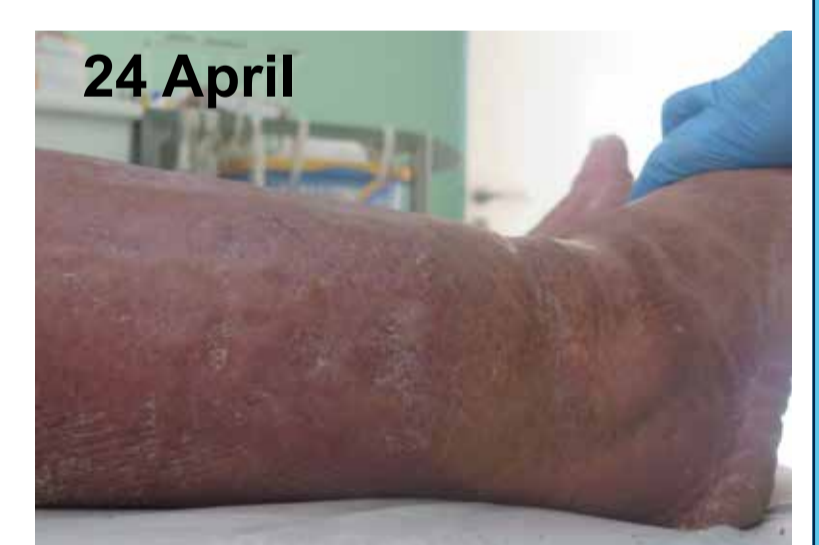
77-year-old male with small (3x3 cm) highly exuding wounds on both legs caused by venous insufficiency and lymphedema. In spite of having received lymphatic drainage and compression three times a week by a lymphedema specialist the wounds were getting worse.

A single treatment with with electrospun nanofiber scaffold was performed on the 23 of March. Due to the high exudation the wounds were covered with a super-absorbent dressing with a built-in wound contact layer that does not adhere to the matrix. Lymphatic drainage and compression still continue as part of his regular treatment.

Complete closure by the 21st of April (photo taken on the 24th April).

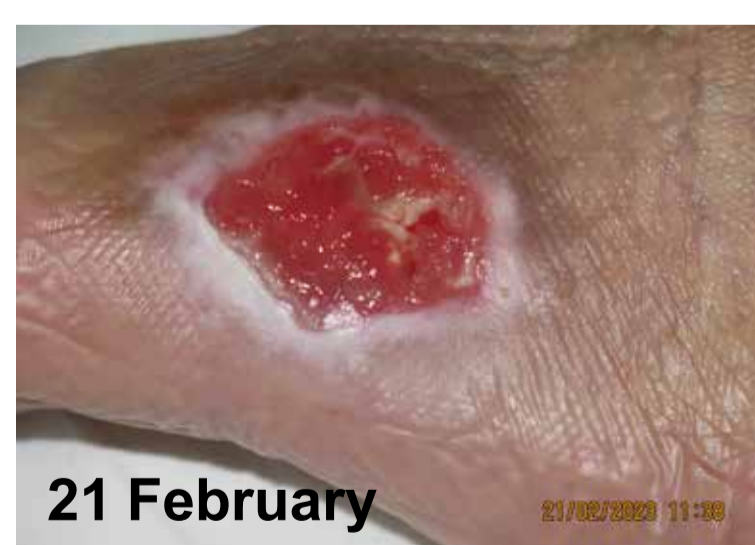
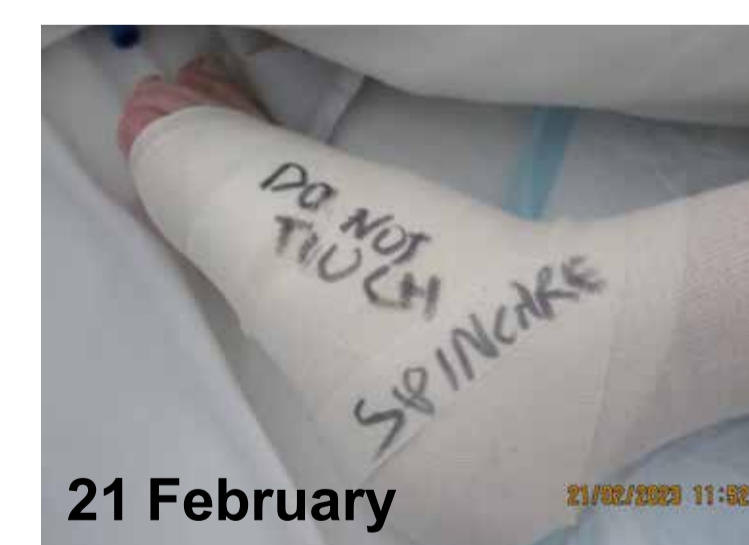
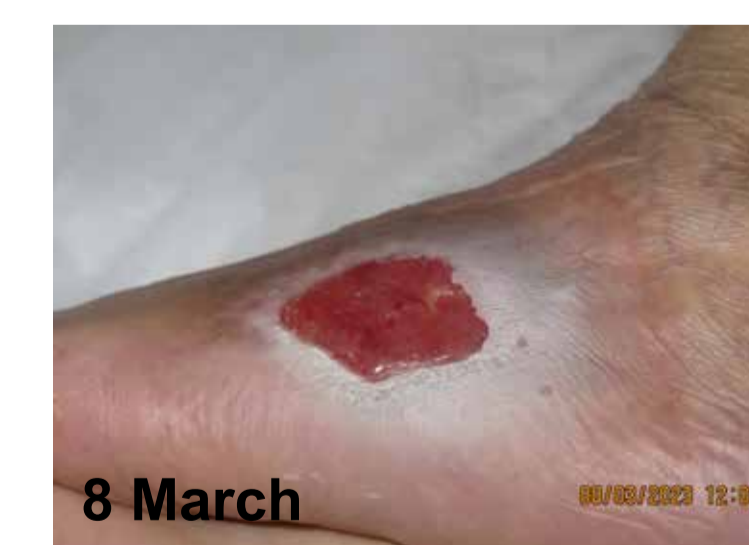
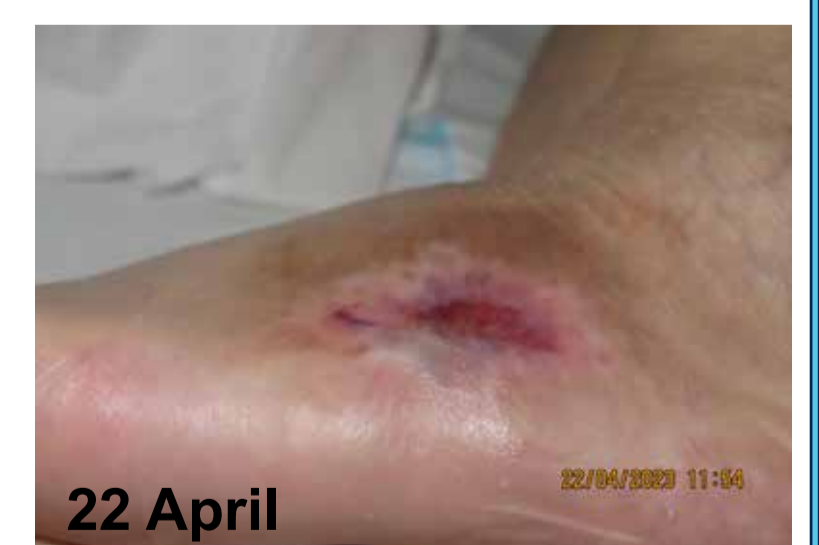
72-year-old male with uncontrolled diabetes and neuropathy developed a PU from using ill-fitting shoes. Various treatments were used, collagenase enzyme for debridement, Hyaluronic acid, hydrofibers and alginates. Duration of wound five months.

Eight weeks after we applied the first electrospun nanofibrous matrix on the the wound it had closed. A total of four applications were needed. A silicon based wound contact layer and non-woven gauze was used on top of the matrix. Since the wound was relatively dry it would have been enough to change the secondary dressings once a week. Due to the insecurity of the patient and his nurses they opted to change every other day. Our impression was that this scaffold matrix help to provide the environment for the wound to turn from chronic characteristic to an acute one towards completion of the healing process.
